Incorrect Label on Side Terminal Junctions of Liftgate Charging Noseboxes

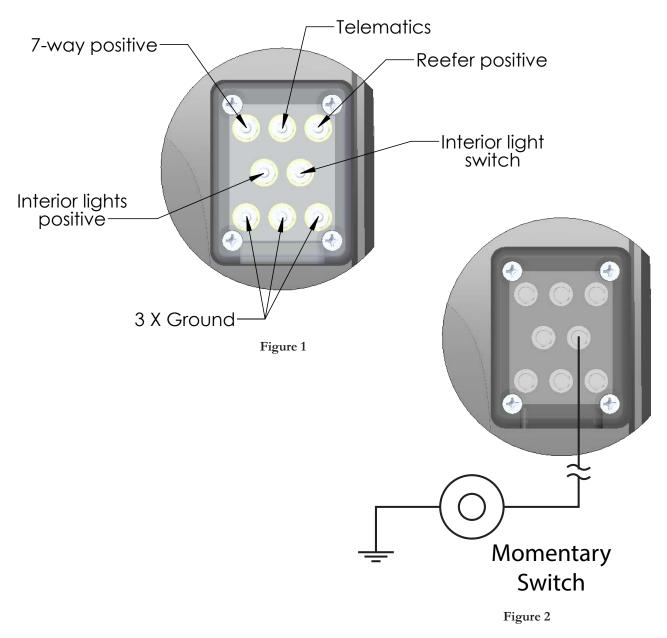
The User Guide had the side terminal junctions for the "Interior Light Positive" and "Interior Light Switch" in opposite positions. Please disregard the original User Guide's side terminal junction call out and refer to Figures 1 and 2 below for the CORRECT junction call out. This error has been corrected in Doc 2.01 of the Plus/Flex/Max guide and Doc 1.02 of the Select/Direct guide. We apologize for any inconvenience that this may have caused.
