Service Bulletin

Checking Low Voltage to Liftgate Charging Nosebox Systems

Excessive Voltage Drop Troubleshooting

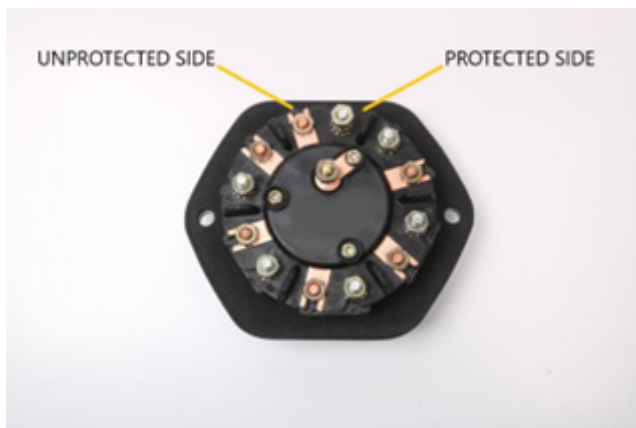
One possible cause is a bad or undersized circuit breaker.

To repair this, inspect circuits inside the 7-way box for excessive electrical resistance caused by overheating, corrosion, loose/poor connections, or undersized wiring.

Check to see if the 7-way is equipped with circuit breakers (see Figure 1 and Figure 2), as the problem may be a failing circuit breaker. Connect the blue wire from the LGCS nosebox to the unprotected side of the circuit breaker. In this case, circuit protection for the charging system will be covered by the 30-amp fuses in the LGCS nosebox.
