# Service Bulletin

## Checking Low Voltage to Liftgate Charging Nosebox Systems

### Excessive Voltage Drop Troubleshooting

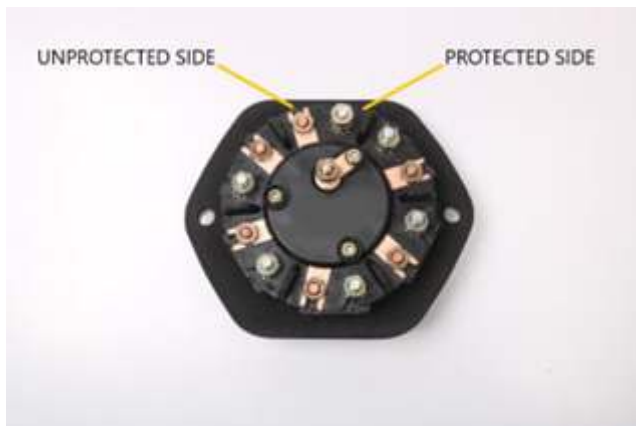
One possible cause is a bad or undersized circuit breaker.

To repair this, inspect circuits inside the 7-way box for excessive electrical resistance caused by overheating, corrosion, loose/poor connections, or undersized wiring.

Check to see if the 7-way is equipped with circuit breakers (see Figure 1 and Figure 2), as the problem may be a failing circuit breaker. Connect the blue wire from the LGCS nosebox to the unprotected side of the circuit breaker. In this case, circuit protection for the charging system will be covered by the 30-amp fuses in the LGCS nosebox.
