Technical Bulletin

Nosebox Side Connections

Incorrect Label on Side Terminal Junctions of Liftgate Charging Noseboxes

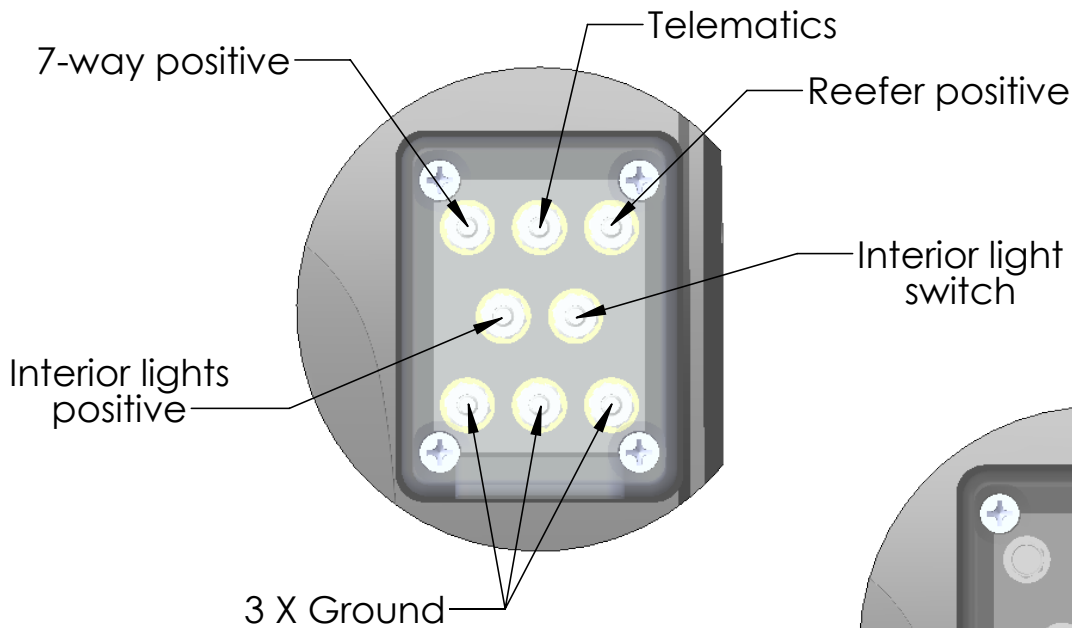
Figure 1

The User Guide had the side terminal junctions for the “Interior Light Positive” and “Interior Light Switch” in opposite positions. Please disregard the original User Guide’s side terminal junction call out and refer to Figures 1 and 2 below for the CORRECT junction call out. This error has been corrected in Doc 2.01 of the Plus/Flex/Max guide and Doc 1.02 of the Select/Direct guide. We apologize for any inconvenience that this may have caused.
