# Service Bulletin

## Checking Low Voltage to Liftgate Charging Nosebox Systems

### Excessive Voltage Drop Troubleshooting

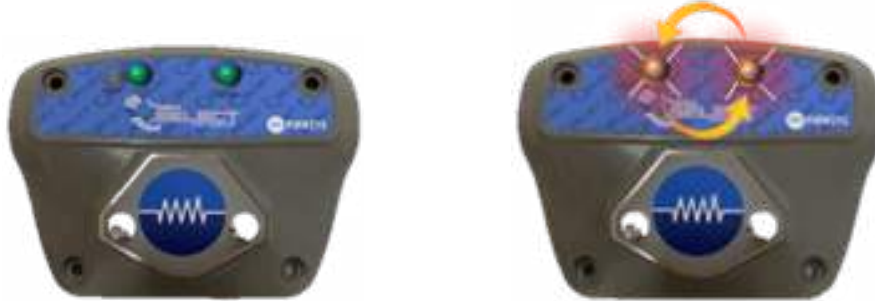
When troubleshooting a liftgate charging system and there is a solid green LED on both the source and lift battery lights, and those lights switch to flashing orange lights and back to solid green, this means there is a voltage drop going into the Purkeys liftgate battery charging system (LGCS) from the truck.
